Data Analysis Isolates Water Main Breaks

To address pipe break problems within its distribution system, Missouri American Water (MOAW) worked with a monitoring and analysis company to find the causes and solutions, ultimately giving the utility valuable insights.

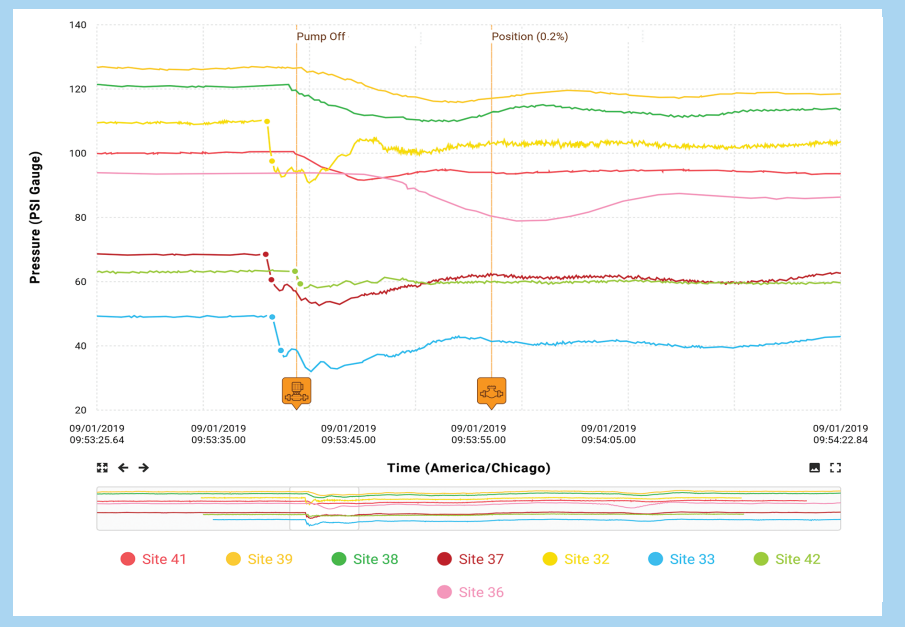
Figure 2. A Recurrent Pressure Drop

A graph shows a transient event detected by all devices. Overlaid SCADA data showed that a pump at a nearby pump station was turned off.

Recurring Pressure Loss. In a final example, a review of pressure data on one specific area revealed a recurrent drop that reached up to 15 psi in range and propagated through most of the survey sites across that area. The high sample rate data were used to triangulate the source of the event. The result of the triangulation was located close to a pump station in one of the surveyed zones. SCADA data were overlaid on the pressure data, showing that one of the pumps at the pump station was turned off, creating a transient event that was detected in the surrounding area (Figure 2).
